Facility Executive Summary

Facility: California Community Colleges\San Joaquin Delta CCD

Surveyor:  
Woody Nelson

Date:  
18-Nov-2002

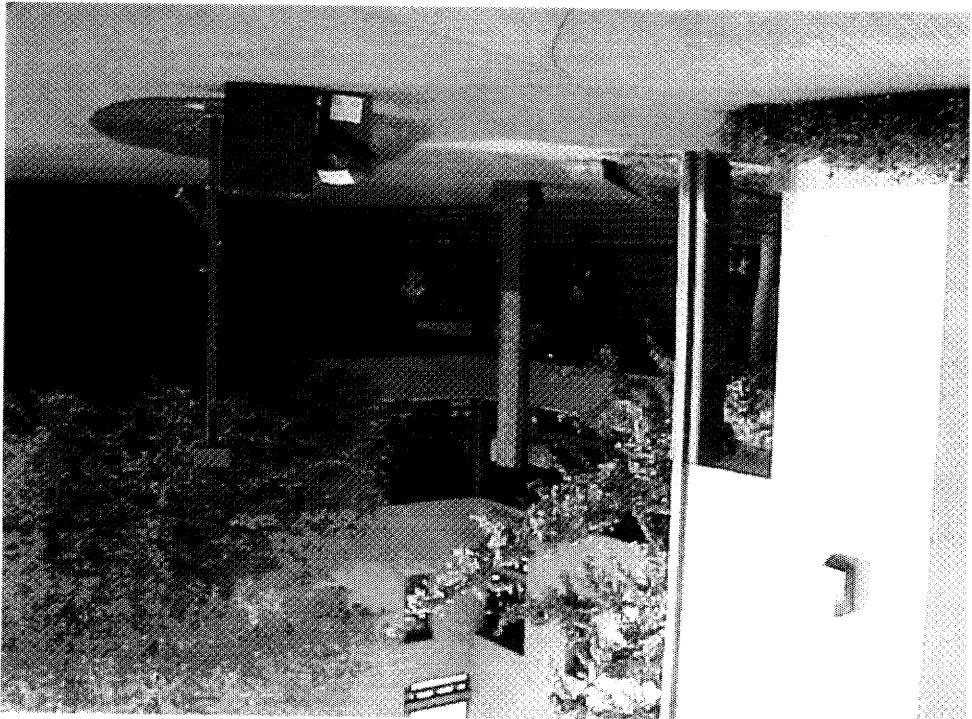
Facility: California Community Colleges\San Joaquin Delta CCD\51 Cunningham Center

Light weight stamped concrete sidewalks immediately adjacent to the facility are in poor condition and pose a hazard and need replacement.

The partitions in the building are typically gypsum board. The ceilings are glue-on ceiling tile that is beyond its useful life and needs replacement. Floors are smooth concrete and carpeting. The carpet is worn and stained and needs replacement in most areas. Concrete floors are stained and need refinishing. Interior doors are wood with slab faces in steel frames. Door hardware is in serviceable condition. Restrooms have ceramic tile floors and wainscot that is in good condition. Toilet compartments are metal and damaged and need replacement.

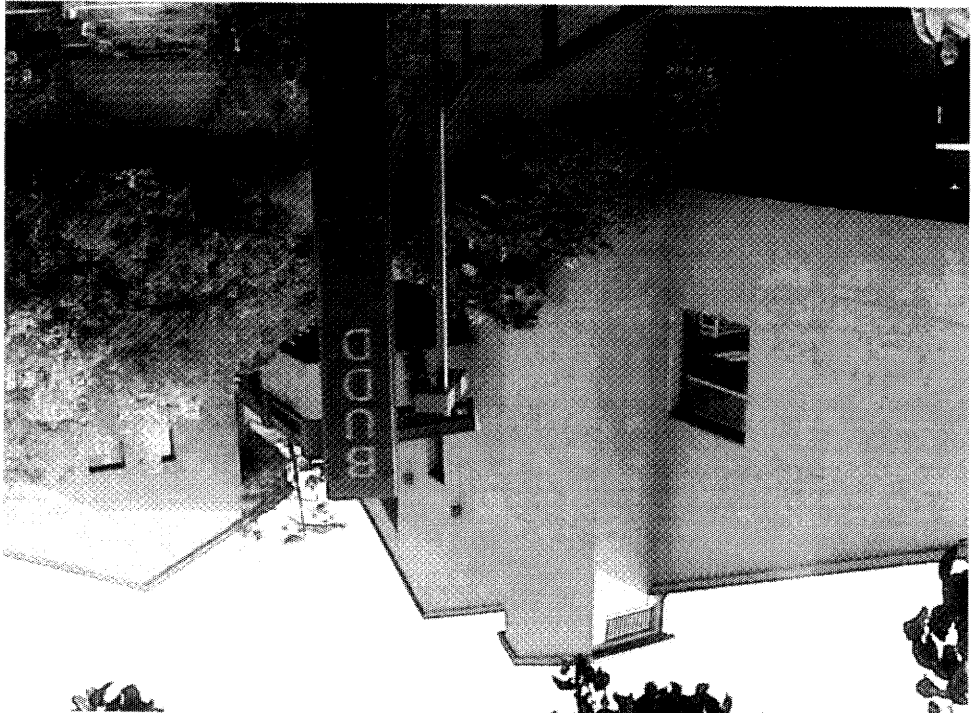
Facility: California Community Colleges\San Joaquin Delta CCD\52 Budd Center

Site:  
Light weight stamped concrete sidewalks immediately adjacent to the facility are in poor condition and pose a hazard and need replacement.

The partitions in the building are typically gypsum board. Walls throughout the building need repainting. The ceilings are glue-on ceiling tile that is beyond its useful life and needs replacement. Floors are smooth concrete, carpeting and VCT. VCT is worn and needs replacement. Interior doors are wood with slab faces in steel frames. Door hardware is in serviceable condition. Restrooms have ceramic tile floors and wainscot that is in good condition. Toilet compartments are metal and damaged and need replacement. Strip hardwood floors in athletic rooms are worn and need refinishing.

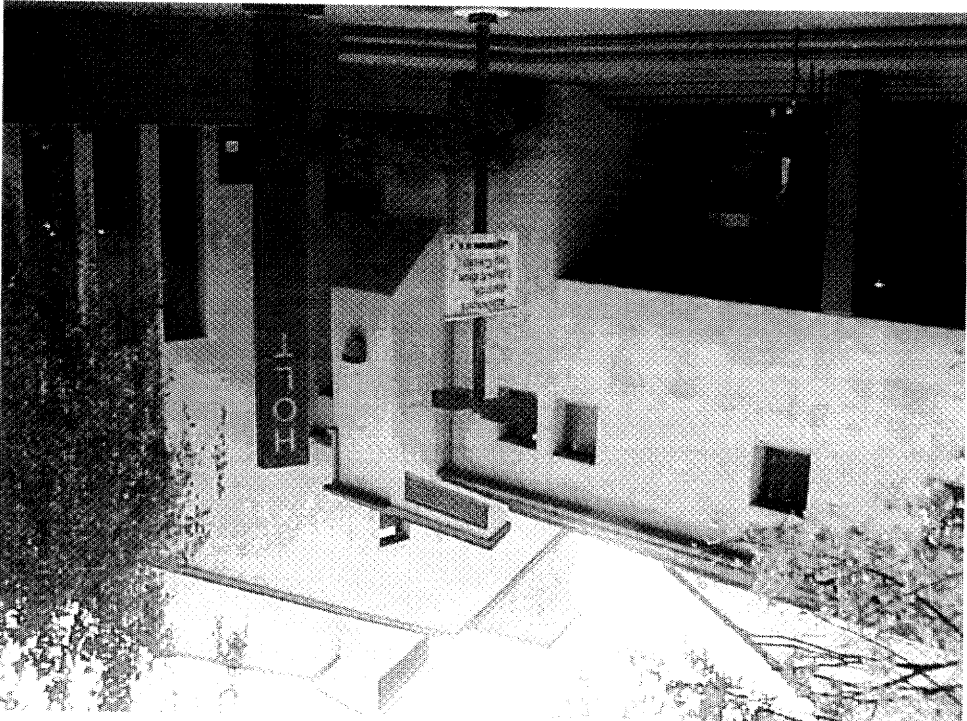
Facility: California Community Colleges\San Joaquin Delta CCD\53 Holt Center

Light weight stamped concrete sidewalks immediately adjacent to the facility are in poor condition and pose a hazard and need replacement.

The partitions in the building are typically gypsum board. The ceilings are glue-on ceiling tile that is beyond its useful life and needs replacement in areas of the building. Floors are smooth concrete, carpeting and VCT. The carpet is worn and stained and needs replacement in most areas. Concrete floors are stained and need refinishing. VCT is worn and needs replacement. Interior doors are wood with slab faces in steel frames. Door hardware is in serviceable condition. Restrooms have ceramic tile floors and wainscot that is in good condition. Toilet compartments are metal and damaged and need replacement.

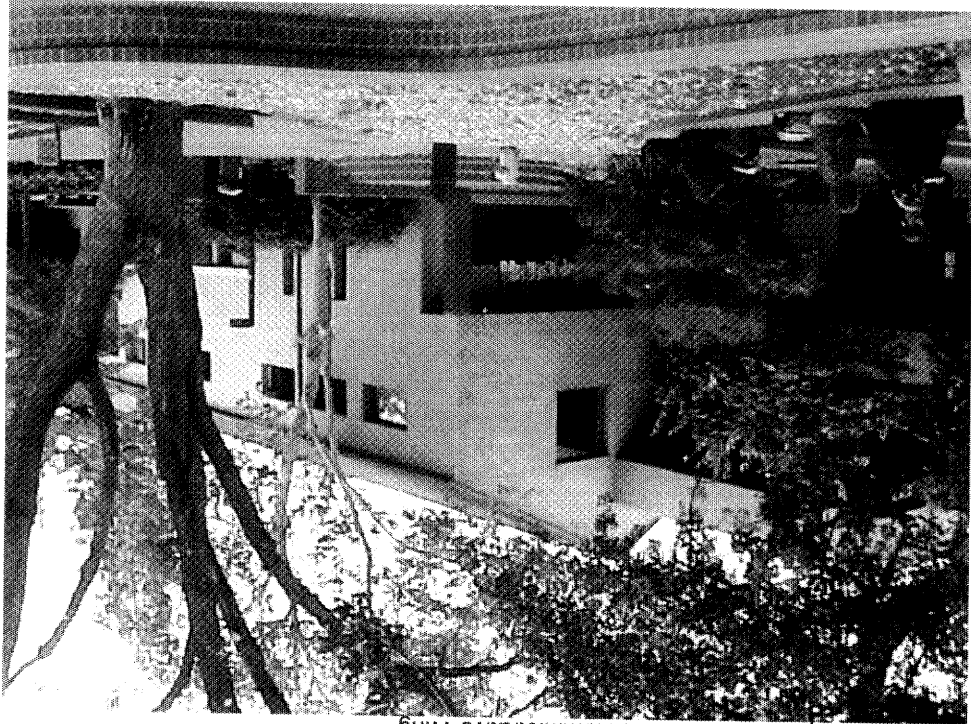
Facility: California Community Colleges\San Joaquin Delta CCD\55 Administrative Wing

Light weight stamped concrete sidewalks immediately adjacent to the facility are in poor condition and pose a hazard and need replacement.

The partitions in the building are typically gypsum board. The ceilings are glue-on ceiling tile. Floors are smooth concrete, carpeting and VCT. Concrete floors are stained and need refinishing. Interior doors are wood with slab faces in steel frames. Door hardware is in serviceable condition. Restrooms have ceramic tile floors and wainscot that is in good condition. Toilet compartments are metal and damaged and need replacement.

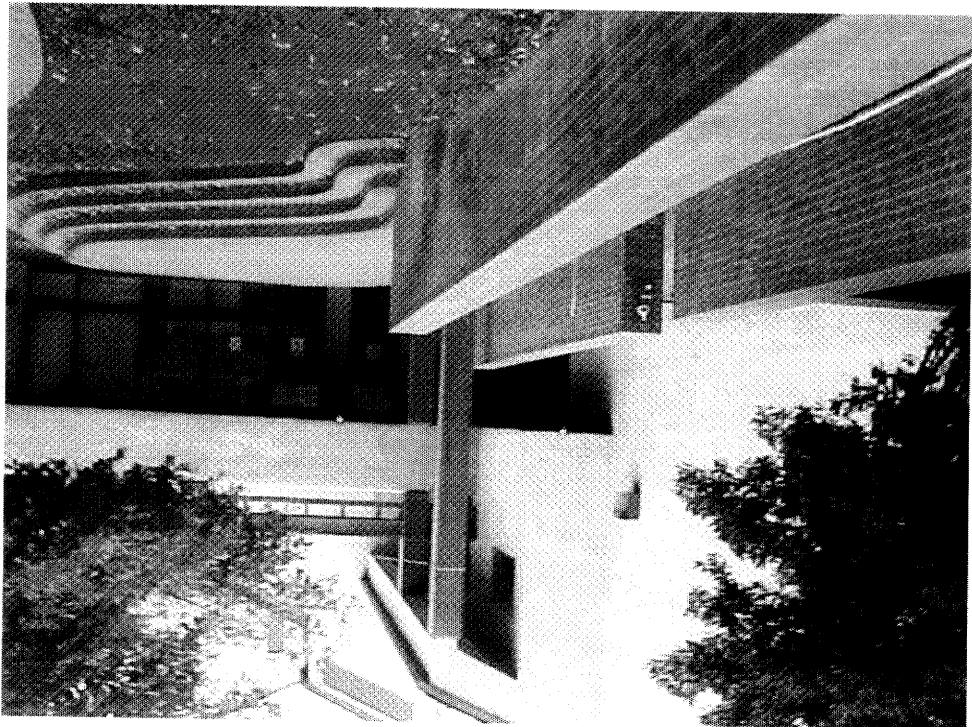
Facility: California Community Colleges\San Joaquin Delta CCD\57 Forum Hall

Site:  
Light weight stamped concrete sidewalks immediately adjacent to the facility are in poor condition and pose a hazard and need replacement.

Interiors:  
The partitions in the building are typically gypsum board. The ceilings are glue-on ceiling tile that are outdated and need replacement. Floors are smooth concrete, carpeting and VCT. Carpet is worn and stained and needs replacement. Concrete floors are stained and need refinishing. VCT needs replacement in some areas. Interior doors are wood with slab faces in steel frames. Door hardware is in serviceable condition. Restrooms have ceramic tile floors and wainscot that is in good condition. Toilet compartments are metal and damaged and need replacement.

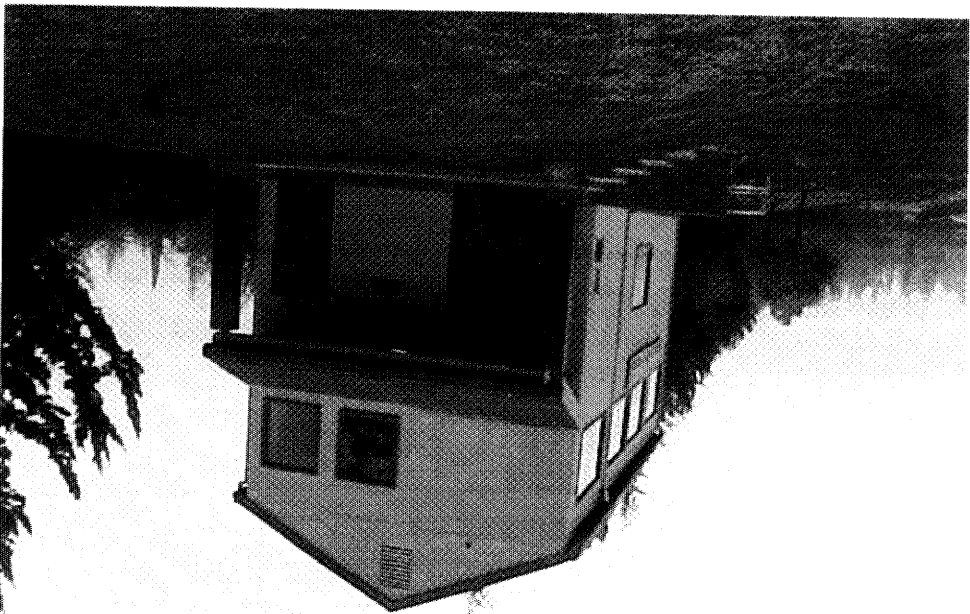
Facility: California Community Colleges\San Joaquin Delta CCD\63 Football Score Booth

The partitions in the building are typically gypsum board. Floors are carpet and smooth concrete. Carpets are stained and need replacing and concrete floor needs refinishing. Interior doors are wood with slab faces in steel frames. Door hardware is in serviceable condition.

The electrical system is fed from a pad mounted transformer that delivers 120/208 V, 3 phase, 4-wire power to the facility. Lighting is typically fluorescent and illumination is generally inadequate. Emergency lights are not present. Emergency exit signs are not present. The building does not have an emergency generator.

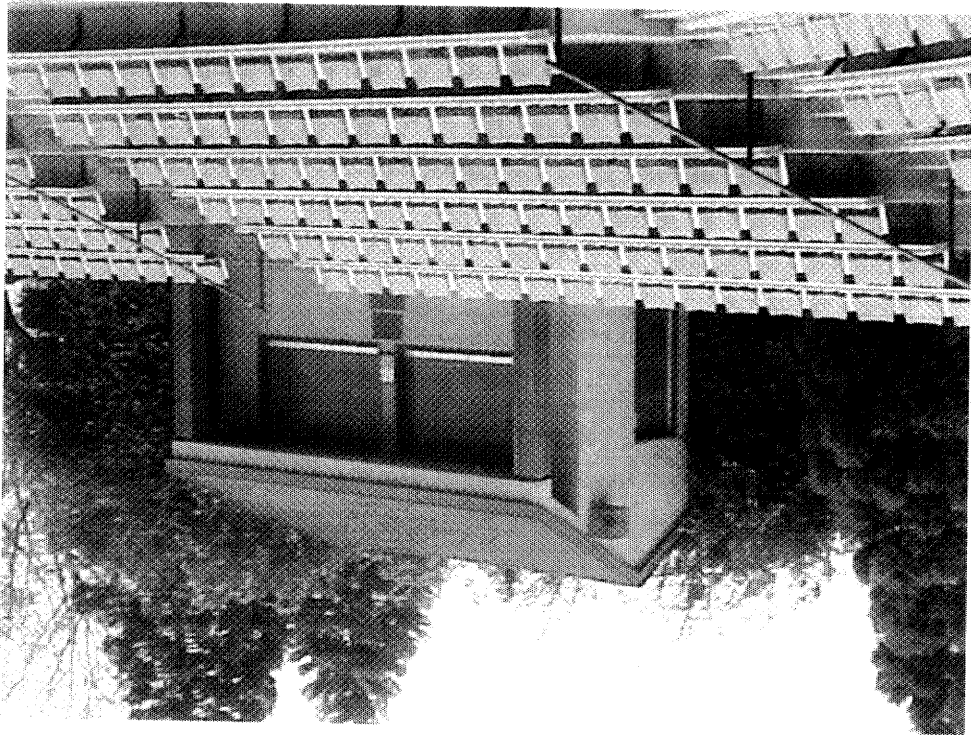
Facility: California Community Colleges\San Joaquin Delta CCD\64 Baseball Scorekeeper Booth

Site:  
Light weight stamped concrete sidewalks immediately adjacent to the facility are in poor condition and pose a hazard and need replacement.

Interiors:  
The partitions in the building are typically gypsum board. Floors are carpet. Carpet is stained and need replacing. Interior doors are wood with slab faces in steel frames. Door hardware is in serviceable condition.
