To help document the need for funding the necessary replacement and upgrading of facilities within California's community college districts and to assist districts in preparing for bond issues, the Foundation for California Community Colleges (FCCC) negotiated a discounted-pricing agreement for facilities condition assessments with 3D/International. In Summer 2001, the FCCC issued a formal Request For Information (RFI) in a public newspaper and subsequently reviewed, considered, and evaluated the respondents' experience and quality of work, particularly work with higher education clients. San Joaquin Delta College District (SJDCCD) elected to participate in the joint agreement and contracted with 3D/I to assess and document the facility repair, rehabilitation, modernization requirements relative to the SJDCCD.

Over a period of about two months, a staff of six 3D/International planning and construction professionals working with the Chancellor's Office performed an Existing Facility Assessment. The following report presents 3D/International's findings.

The Assessment of Existing Facilities section reports on the current physical condition of thirty buildings, totaling approximatel

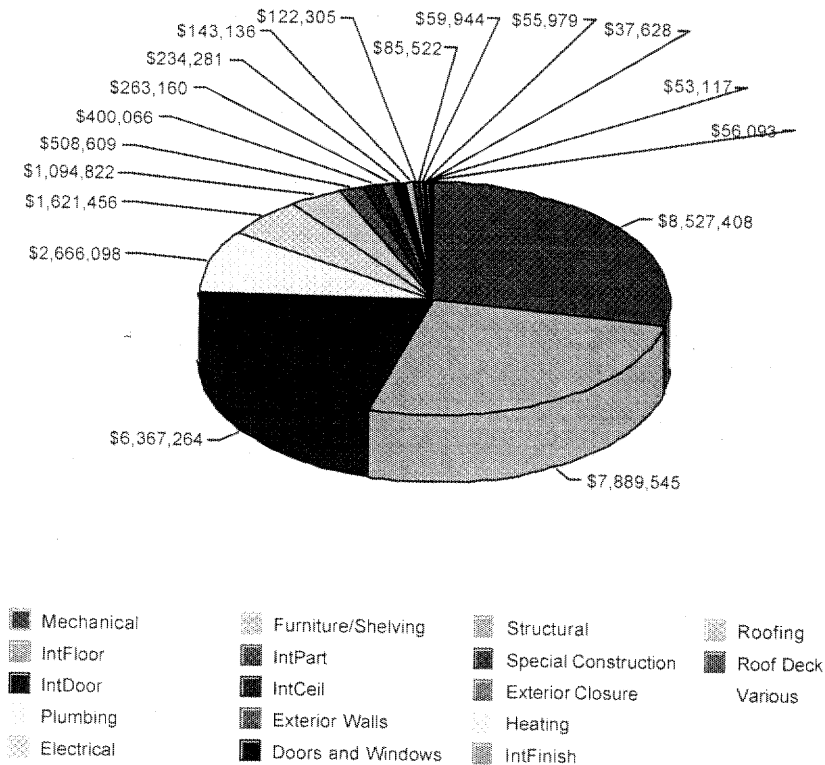
Estimate by Building System – San Joaquin Delta College

In general, the majority of the costs identified in the assessment are for mechanical and electrical systems. Within mechanical systems, most costs are for adding or replacing chillers, boilers, and associated components such as air handlers and ductwork. The majority of the electrical system costs are for replacing lighting fixtures and providing additional capacity to the main service and branch circuits.

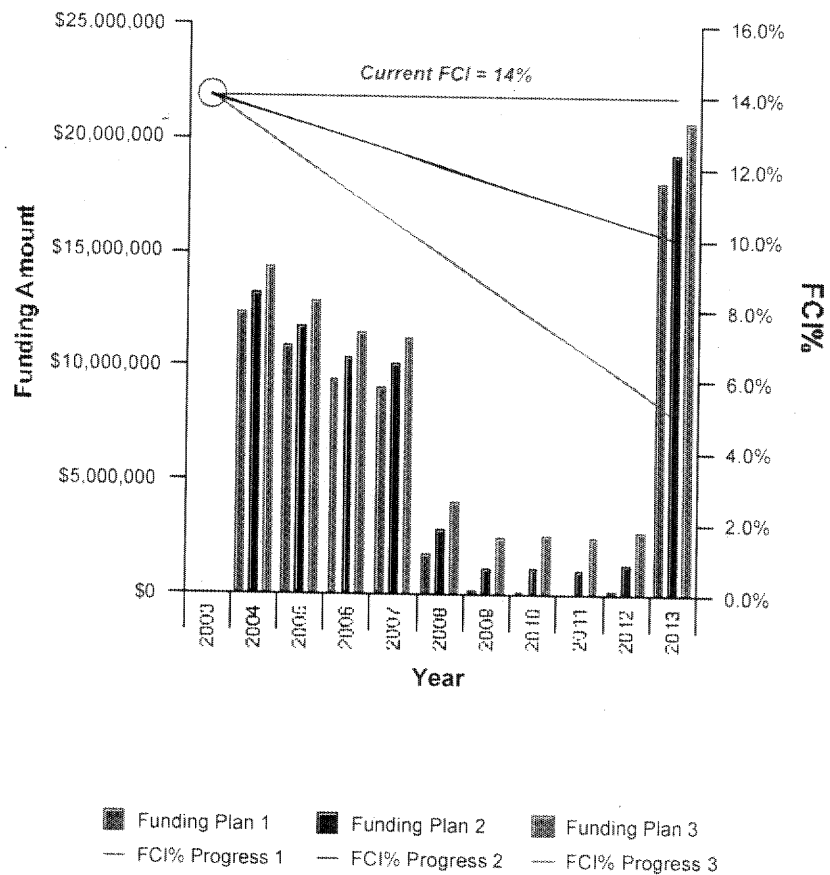
Future Facility Funding vs. FCI for San Joaquin Delta College

The following chart illustrates the 10-year total funding requirements for the San Joaquin Delta College District for three (3) funding scenarios. It shows the combined funding needed for correcting the assessed deficiencies and the predicted capital renewal requirements. Using this chart, we can query:

The red line assumes no spending in the current year (2003) for current deficiencies. Capital renewal costs, as shown, over the next 10 years would be required to maintain the current FCI. The total to keep the FCI stable is approximately \$62.2 million.

The green line assumes no spending in the current year (2003) for all current deficiencies. It assumes a consistent level of funds for the next 10 years to buy-down the current deficiencies and additional funding for capital renewal items to achieve an FCI of 10%. (Minimal standard as published by APPA.) The total to reduce the FCI to 10% is approximately \$72.4 million.

The blue line assumes no spending in the current year (2003) for all current deficiencies. It assumes a consistent level of funds for the next 10 years to buy-down the current deficiencies and additional funding for capital renewal items to achieve an FCI of 5%. The total to reduce the FCI to 5% is approximately \$85.1 million.

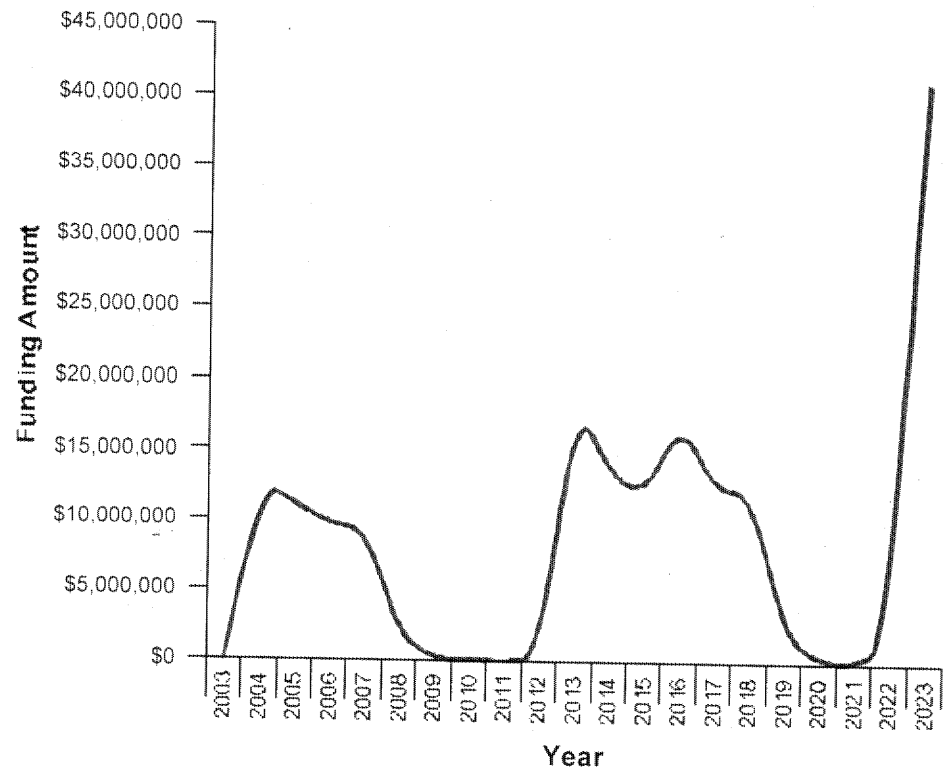
## Facility Renewal Forecast for San Joaquin Delta College

The cost models for each building give us a method to predict future needs for capital renewal. Each model allows us to assess the remaining life of each of the main systems in the building and to enter the expected time of replacement of such systems. Although each model is only a rough approximation for one building, over a larger sample size use of these cost models produces a reliable estimate of the yearly cost to replace building systems. This chart illustrates a 20-year projection of capital renewal funding requirements, excluding current deficiencies for the entire district.
